# Manhole Inspection Summary

Manhole # S19Y\_\_017MH

Insp Date: **6/5/08 10:20 AM**

**Location** Address: **2470 washington-james alley**

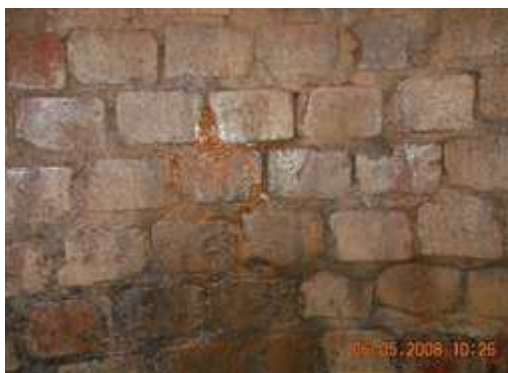
Defect 2

infiltration @ barrel wall

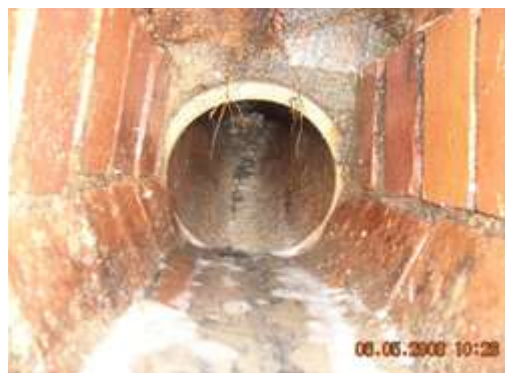
Defect 4

Barrel Roots

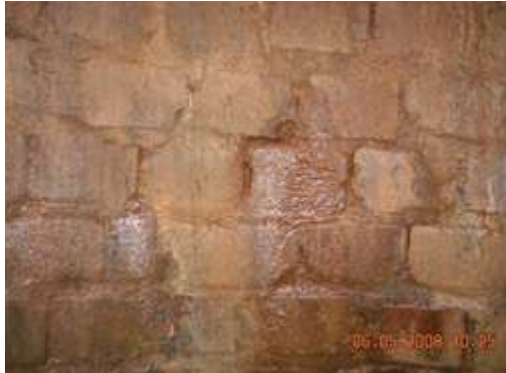
### Defect 1

infiltration @ corbel wall

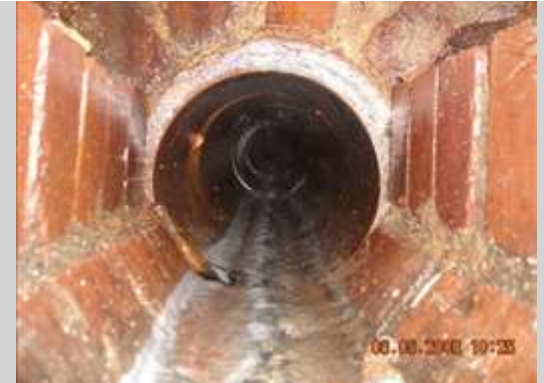
12 O'Clock Outflow

8 in. Circular Gravity Sewer  
Pipe Out @ 12 O'Clock

Pipe Height: **8.4** (in.) Rod and Bar (Angled)  
Pipe Material: **Clay** ☐ Pipe Lined  
Invert Depth: **8.20** (ft.) Flow Characteristics: **Slow**  
Deposits: ☒ None ☐ Mud ☐ Sludge ☐ Debris ☐ Grease  
Silt Depth: **0** (in.) Deposits Extent:  
Infiltration: **None** Pipe Seal Cond: **Sound**

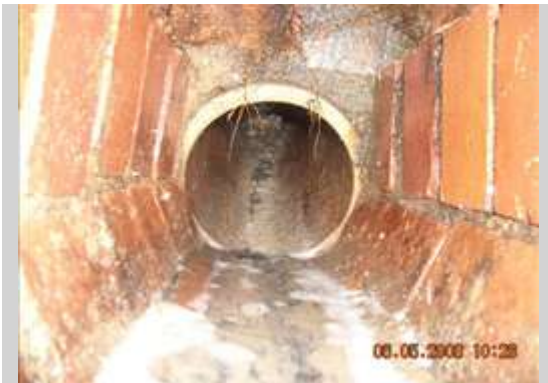
5 O'Clock Inflow

6 in. Circular Gravity Sewer  
Pipe In @ 5 O'Clock

Pipe Height: **6** (in.) Rod and Bar (Angled)  
Pipe Material: **Clay** ☐ Pipe Lined  
Invert Depth: **8.10** (ft.) Flow Characteristics: **Slow**  
Deposits: ☒ None ☐ Mud ☐ Sludge ☐ Debris ☐ Grease  
Silt Depth: **0** (in.) Deposits Extent:  
Infiltration: **None** Pipe Seal Cond: **Roots**
